AFML-TR-66-310
PART V
VOLUME III

The work presented in this volume is concerned with the performance prediction, testing, and post-test evaluation of a representative graphite-fiber, resin-matrix aircraft fuselage component. Additional material properties were determined and structural margins of safety defined by discrete element analysis. After seven response tests under various load combinations, the component was tested to destruction under combined bending and shear loads. Failure occurred at 110 percent of the target design load but below the failure load predicted from tests on flat panels. A weight saving of 27 percent over an aluminum structure of equivalent strength was demonstrated. The component was also three times stiffer than an aluminum structure of the same weight. Performance projections indicate that the same component built with presently available "Thornel" 50S fibers would offer a weight saving of 49 percent. Post-test evaluations included tensile and compression tests on curved skin panels, on stringers, and on stringer-skin combinations. Optical and electron microscopic examination of the fracture surfaces provided further insight into the failure mechanism

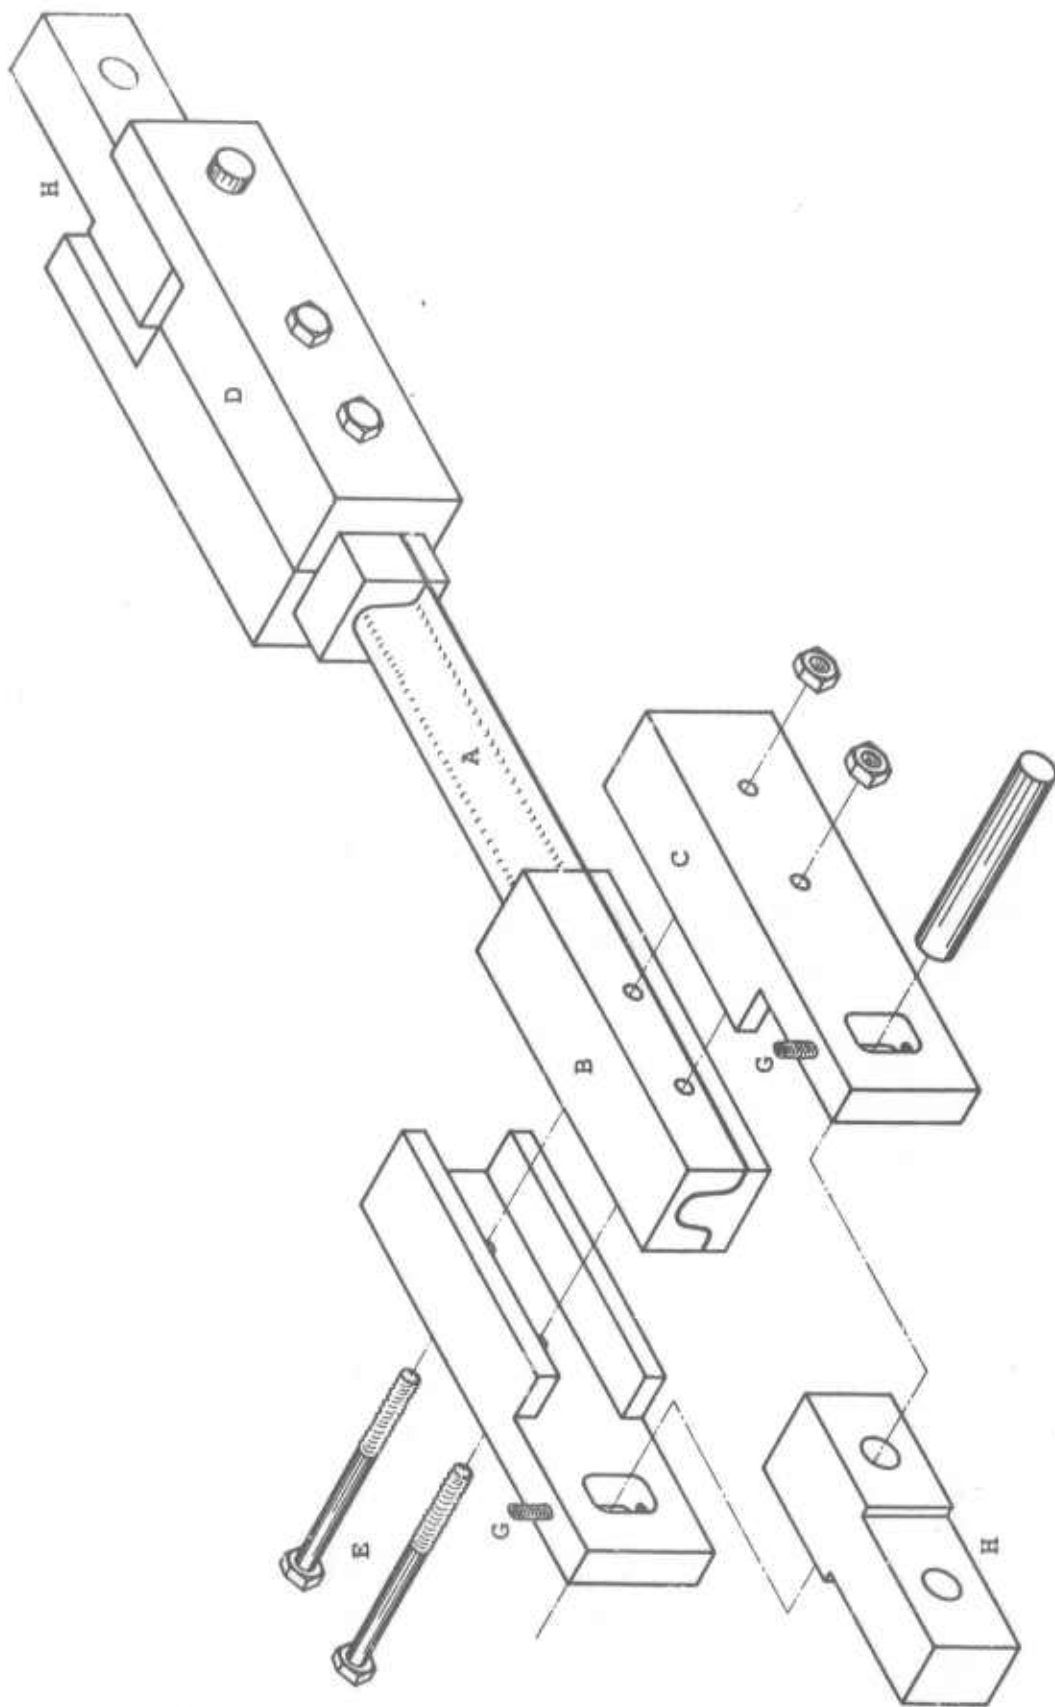
N-23342

Figure 37. Stringer Specimen Assembly for Tensile Test.

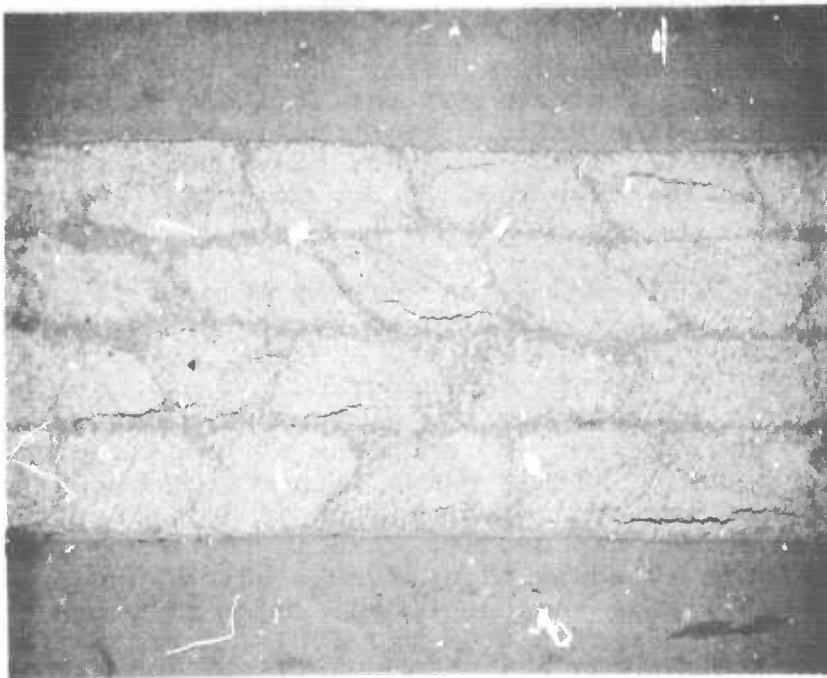
N-23522

Figure 38. Photomicrograph of Web
Section on Hat-Shaped Stringer
Tensile Specimen, H50-223-2.
50X Magnification.

The test of H50-223-2 was terminated just prior to the point at which fracture was expected to occur so that optical examinations on crack formation in the specimen could be made. Figures 38, 39, and 40 show photomicrographs of this stringer. Small cracks running parallel to the sidewalls, shown in Figure 38, were observed in the straight web sections of the stringer. The cracks generally occurred within plies rather than between plies. A photomicrograph of the cap section is shown in Figure 39. Fewer cracks were found in the cap section than in the other areas of the stringer. Figure 40 shows large cracks which were observed in the cap-web and web-flange bend sections. Most of these cracks are believed to have initiated from the external surface, and seldom propagated inward beyond the outermost layer.

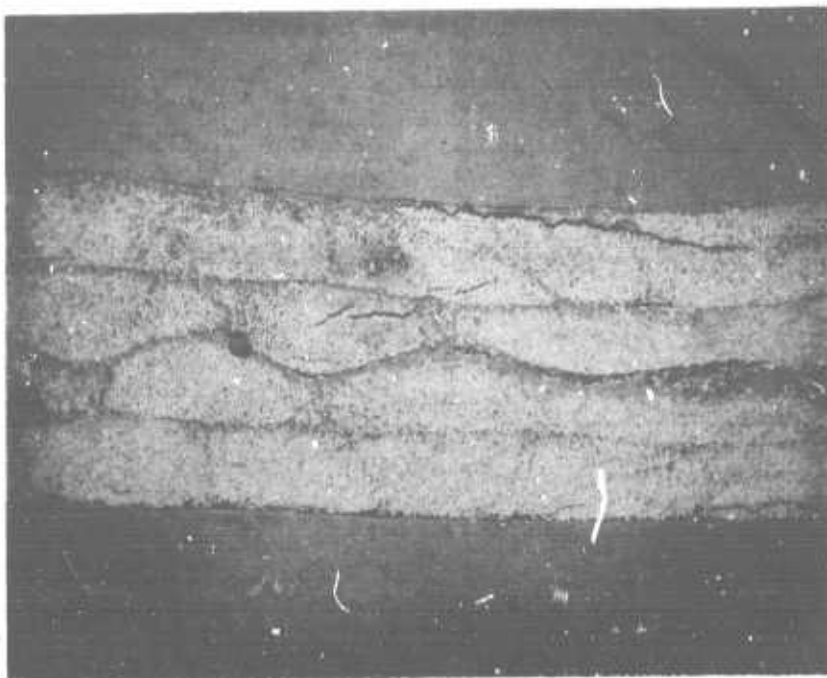
N-23523

Figure 39. Photomicrograph of Cap
Section on Hat-Shaped Stringer
Tensile Specimen, H50-223-2.
50X Magnification.

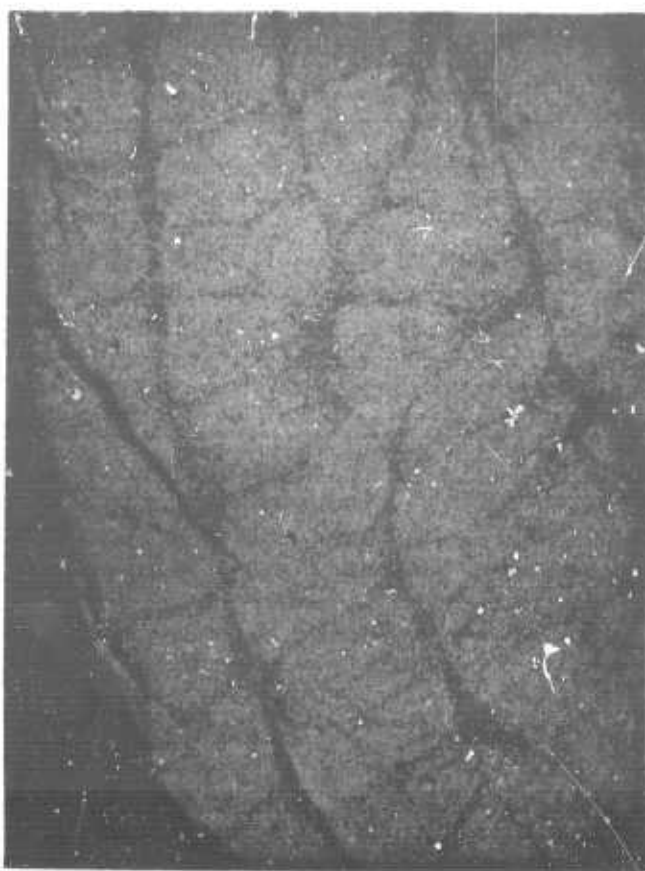
Figure 40. Photomicrograph of Web-Flange Section of Hat-Shaped Stringer Tensile Specimen, H50-223-2. 50X Magnification.

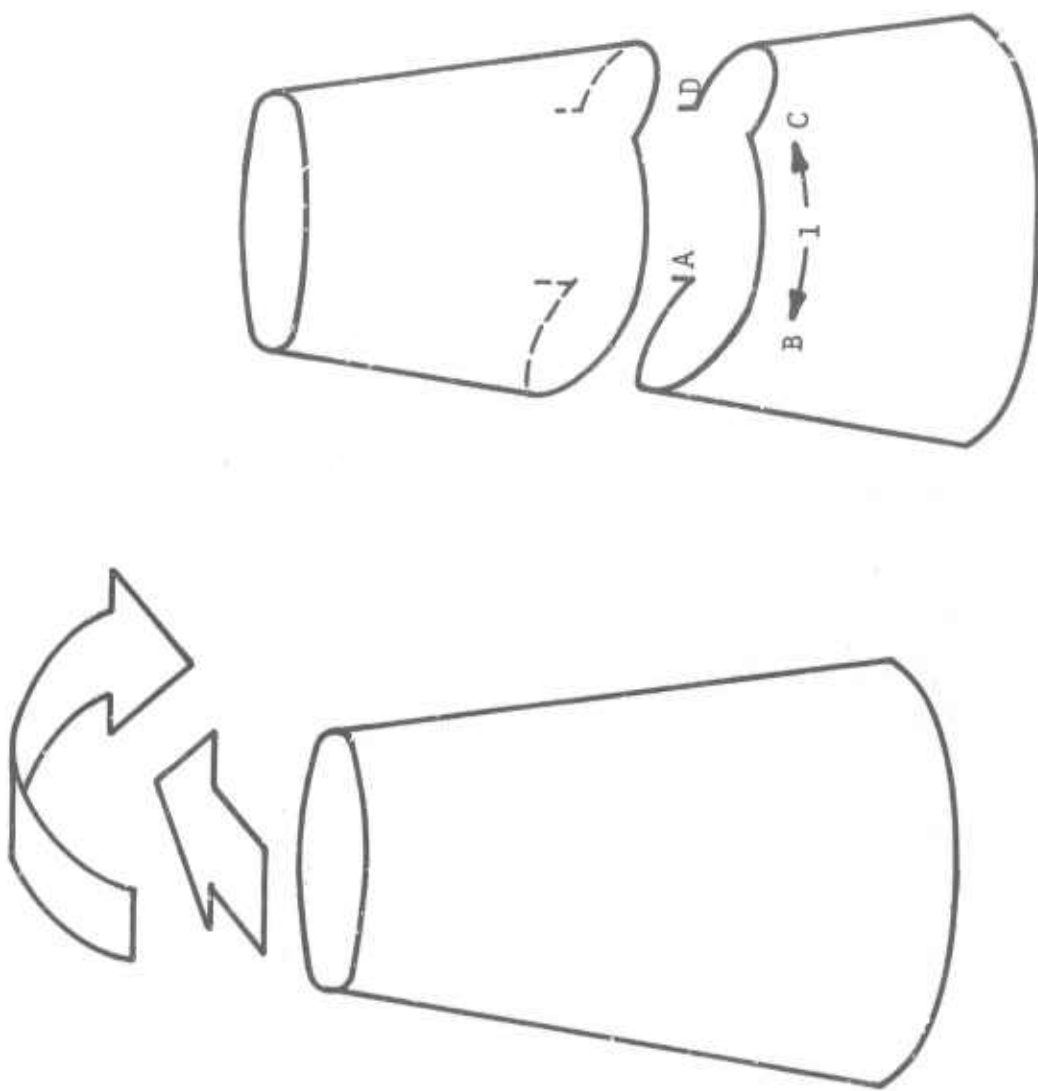
Figure 41. General Orientation of the Fuselage Fracture Surface

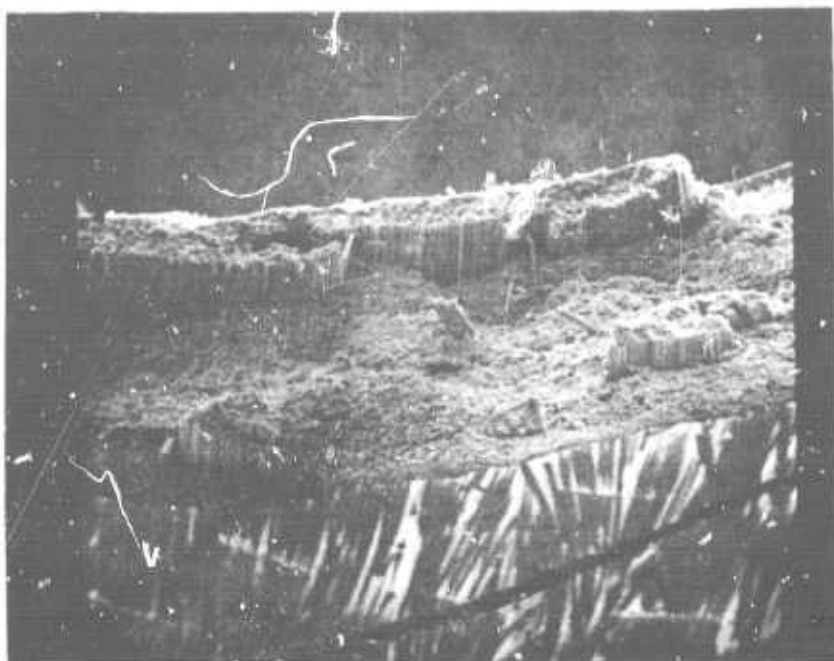
P700077

Figure 42. Scanning Electron Microscope Photograph of the Cap of Stringer No. 1

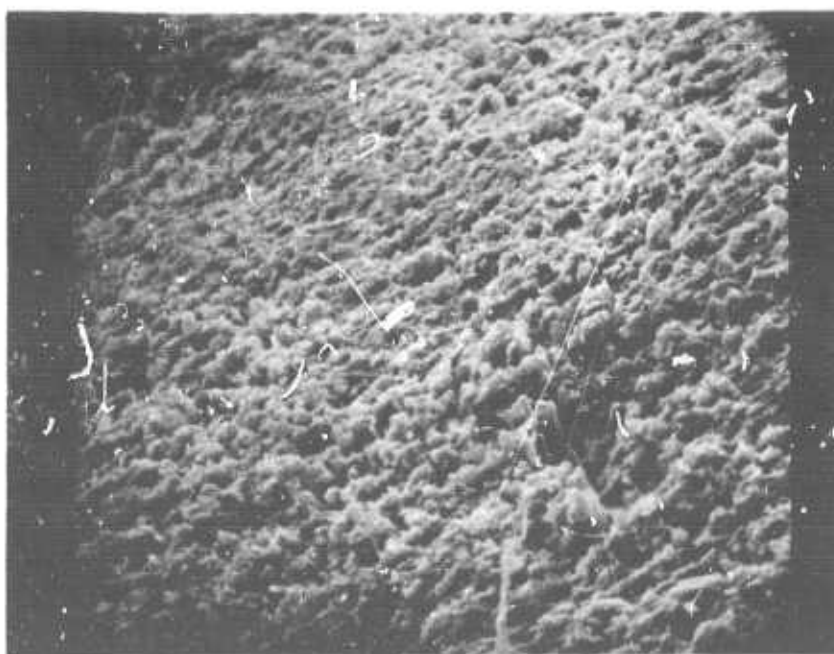
P700078

Figure 43. SEM Photograph of Flat Region of Cap of Stringer No. 1. 500X Magnification.

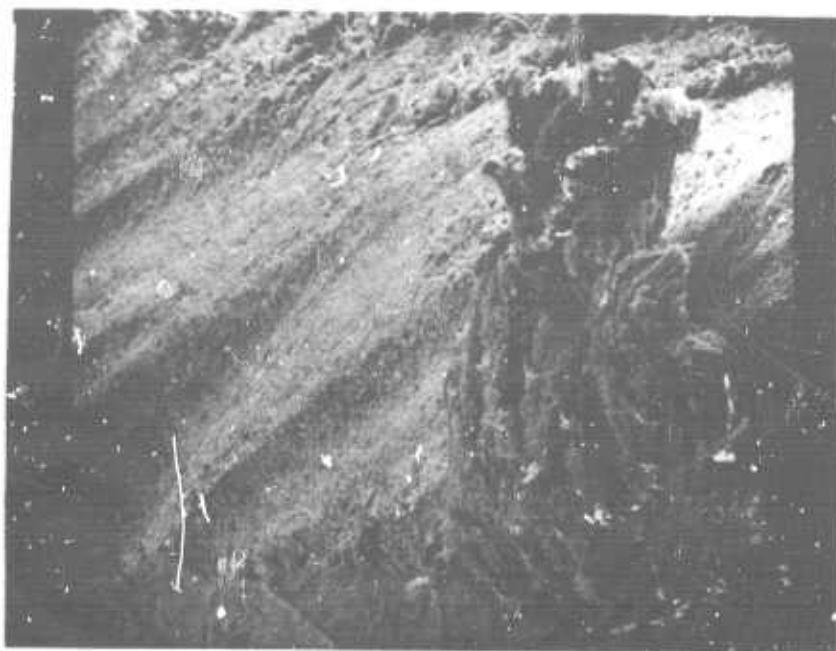
P700079

Figure 44. SEM Photograph of the Cap of Stringer No. 1 Showing a Region of Irregularly Oriented "Thornel" Fibers.

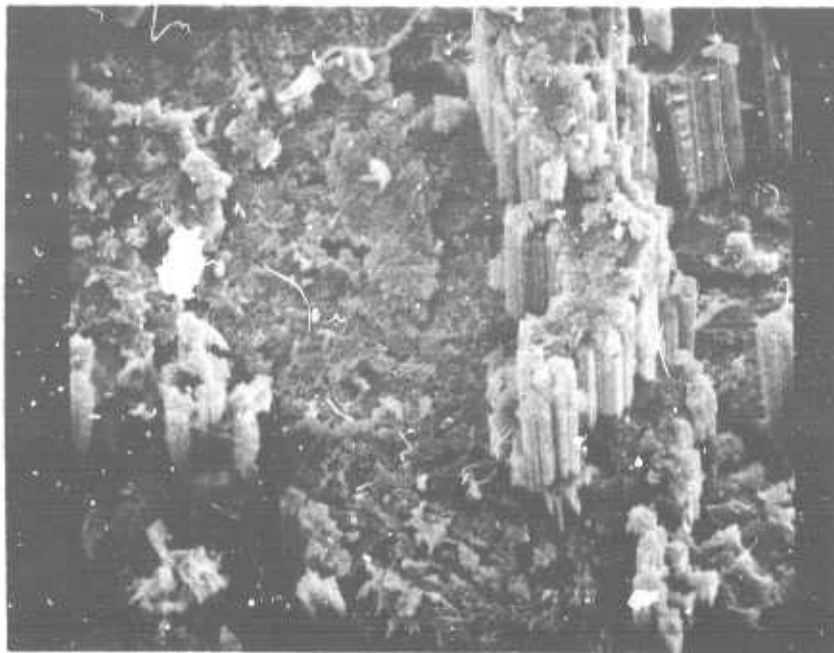
P700081

Figure 46. SEM Photograph of the Root of Stringer No. 1.
500X Magnification.

A closer examination of the fracture surface in the perpendicular region gave a further indication of the direction of crack propagation. When the stringers were bonded to the skin with a room temperature curing adhesive, excess resin collected at the skin-stringer bond region. A close examination of these regions of excess resin revealed fracture origins, mirror and feather markings of a crack propagating through each skin-stringer bond. From the location of the fracture origin and the orientation of the feather markings, the crack appeared to have propagated from the center (stringer No. 1) out to points B and C of Figure 41. Figure 48 shows the fracture surface characteristics of the excess resin of stringer No. 31. The crack appears to have initiated at the right (nearest to stringer No. 1) and propagated to the left. This observation is substantiated by the high speed

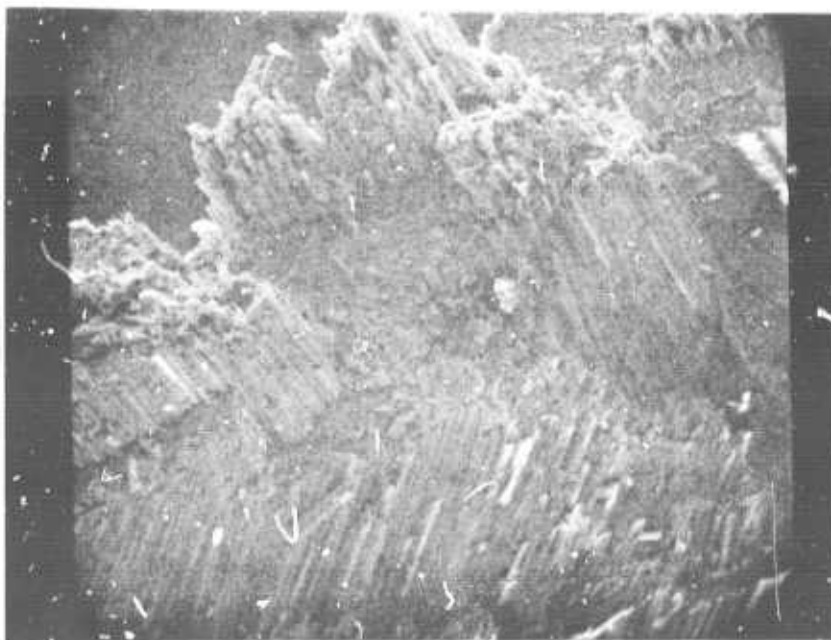
P700082

Figure 47. SEM Photograph of the Cap of Stringer No. 31.
100X Magnification.
